INVESTIGATION OF AN AIRCRAFT ACCIDENT BY FRACTOGRAPHIC ANALYSIS

**R. V. Krishnan, S. Radhakrishnan, A. C. Raghuram and V.
Ramachandran**

Materials Science Division, National Aeronautical Laboratory, Bangalore 560017, India

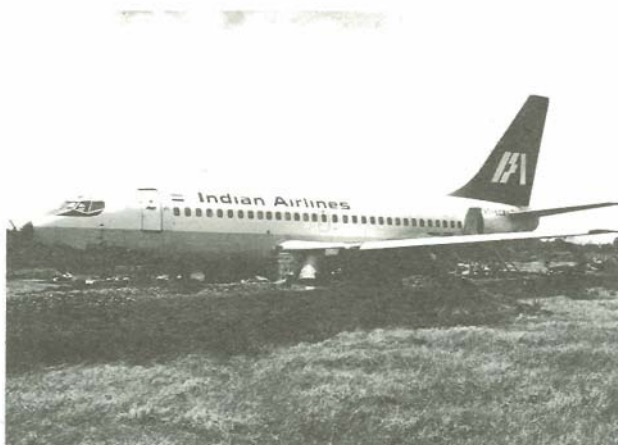
The general view of the damaged aircraft is shown in Fig.1. The engines and the landing gear got ripped off and the aircraft was resting on its belly near the outer fence of the airport. Extensive damage was noticed in the front toilet and the cockpit areas. Fragments were found lodged at various locations such as the pilot's seat, the observer's seat behind the pilot's seat in the cockpit, toilet panels and the panel opposite the toilet across the gangway.

Fig. 1. Wreckage of the aircraft

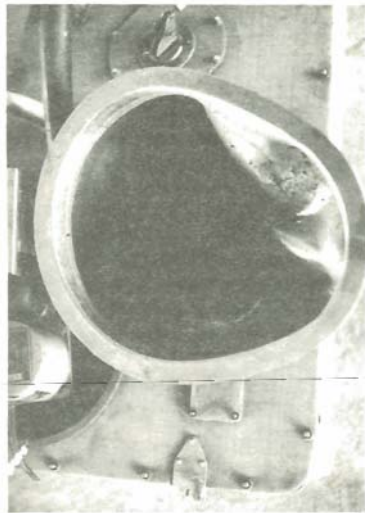
The waste towel receptacle which is an aluminium box kept under the wash basin was found disintegrated into a number of heavily deformed pieces. The toilet bowl located to the left of the waste towel cupboard was found caved in as shown in Fig.3, as though deformed by forces from the direction of the waste towel cupboard.

Fig. 3. Caving in of the toilet bowl

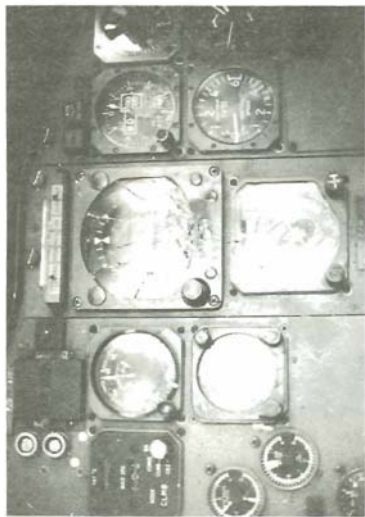
In the cockpit, the glass covers on many of the instruments were found broken as shown in Fig.4. A hole was found on the back rest of the observer's seat which is located between the pilot's seat and the toilet wall. The back rest of the pilot's seat had a hole pierced through it and was damaged as seen in Fig.5.

Fig. 4. Damage to the instrument panel

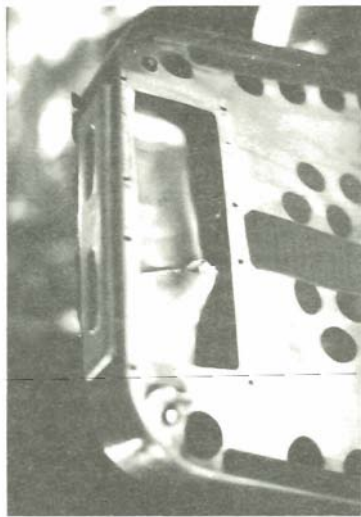
Fig. 5. Back rest of pilot's seat -
Front view

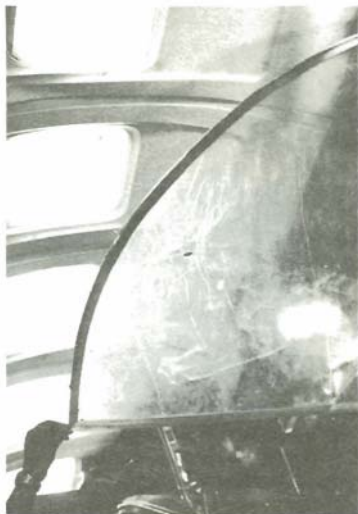
In the passenger cabin, the quadrant shaped translucent plastic panel located in front of the left front row of seats had a hole pierced through it as shown in Fig.6. The cabin crew's folding seat located in the passage between this panel and the front toilet was completely ripped off into small pieces and sharp metal pieces were found embedded in the foam.

Fig. 6. Hole in the plastic panel in the
passenger cabin

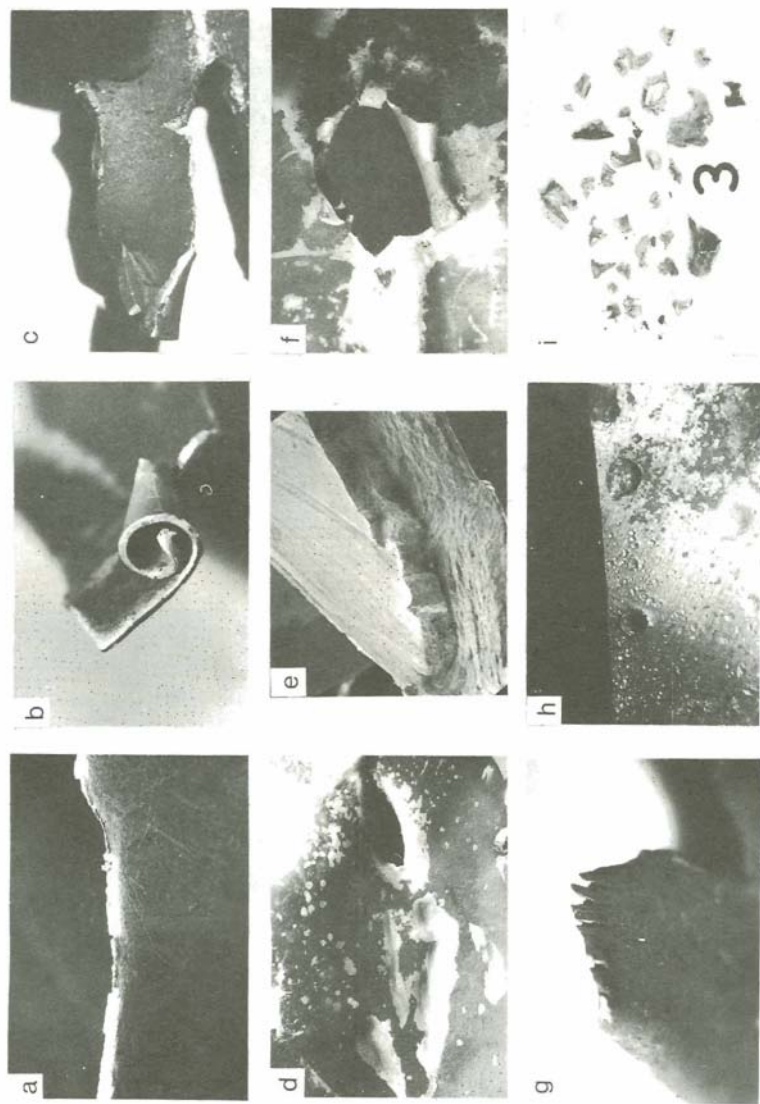
Reverse slant. A number of sheet metal fragments of the waste towel showed a **stepwise** fracture edge, the slope of the slant fracture reversing alternately along the edge, **Fig.7a.**

Curls. Some of the fragments of the waste towel **receptacle** were found curled as shown in **Fig.7b**, with the free end rolled over itself one or two turns.

Curved fragments. Fragments were also found curved at the edges with a small radius of curvature, **Fig.7c.**

Dents. Several sharp and glancing dents were found in some of the pieces of the waste towel receptacle, **Fig.7d.**

Spall. In one of the fragments, metal was found spalled along the midthickness plane. Figure 7e is a scanning electron fractograph of this feature.

Holes. In some of these fragments, small holes were found pierced through the thickness. On larger holes, petaling and outward curling were noticed on the outer surface of the fragments, **Fig.7f.**

Spikes. Saw tooth like spikes were noticed in some of the pieces. One such piece shown in **Fig.7g** was identified as part of the aluminium backing under the stainless steel wash basin.

Craters. In a few pieces identified to be parts of the waste towel receptacle, a cluster of small craters was noticed with raised ridges along the periphery, as shown in **Fig.7h.**

Nondescript fragments. In addition, there were many tiny nondescript fragments of aluminium, of various shapes in the debris collected from the front area, **Fig.7i.**

Fig. 7. Signatures of explosion: (a) Reverse slant (b) Curl (c) Curved fragment (d) Dent (e) Spall (f) Petaling and curling around a hole (g) Spikes (h) Craters (i) Nondescript fragments

The observed features described in the earlier section belong to this group of signatures produced on explosion. While some features like the reverse slant or some form of curled fragments may also be formed by other means, other features described above are produced only due to explosion. Craters with raised rims could not be caused by any other means during an aircraft crash and their presence is an almost certain proof of chemical explosion.

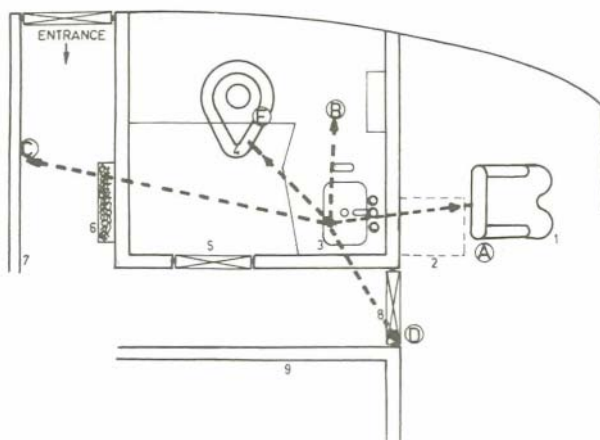
The observed damages to the structure and fittings in and around the toilet compartment further strengthens this view. A hole in the roof skin of the toilet, another in the pilot's seat back rest and a third in the plastic panel in the passenger cabin indicate that high velocity projectiles have travelled outwards in various directions from the toilet. The peeling off of the paint from the top skin of the fuselage between the cockpit and the front entrance, shown in Fig.1 could have happened only due to internal forces from underneath and not during or after landing. The orientation of the dent in the toilet bowl and the deformation of the wash basin indicate the centre of explosion to be under the wash basin. The larger pieces of the disintegrated aluminium waste paper receptacle have dents and holes indicating damage from inside to outside by an explosion. Further the innumerable craters which characterise the primary zone of chemical explosion were found in fragments from this container. All these evidences strongly point to this waste towel receptacle as the centre of explosion. This was also confirmed by the trajectory tracing method sketched in Fig.8. The residues collected from the inside surfaces of the fragments of ~~the waste towel receptacle were got chemically analysed.~~ The analysis indicated that a mixture of ammonium nitrate and fuel oil had been used as the explosive.

Fig.8. Trajectories of projectiles from the centre of explosion
